**COLUMBIA LAKE DAM  
CT 00520**

**PHASE 1. INSPECTION REPORT  
NATIONAL DAM INSPECTION PROGRAM**

**DEPARTMENT OF THE ARMY  
NEW ENGLAND DIVISION, CORPS OF ENGINEERS  
WALTHAM, MASS.**

**SEPTEMBER 1978**

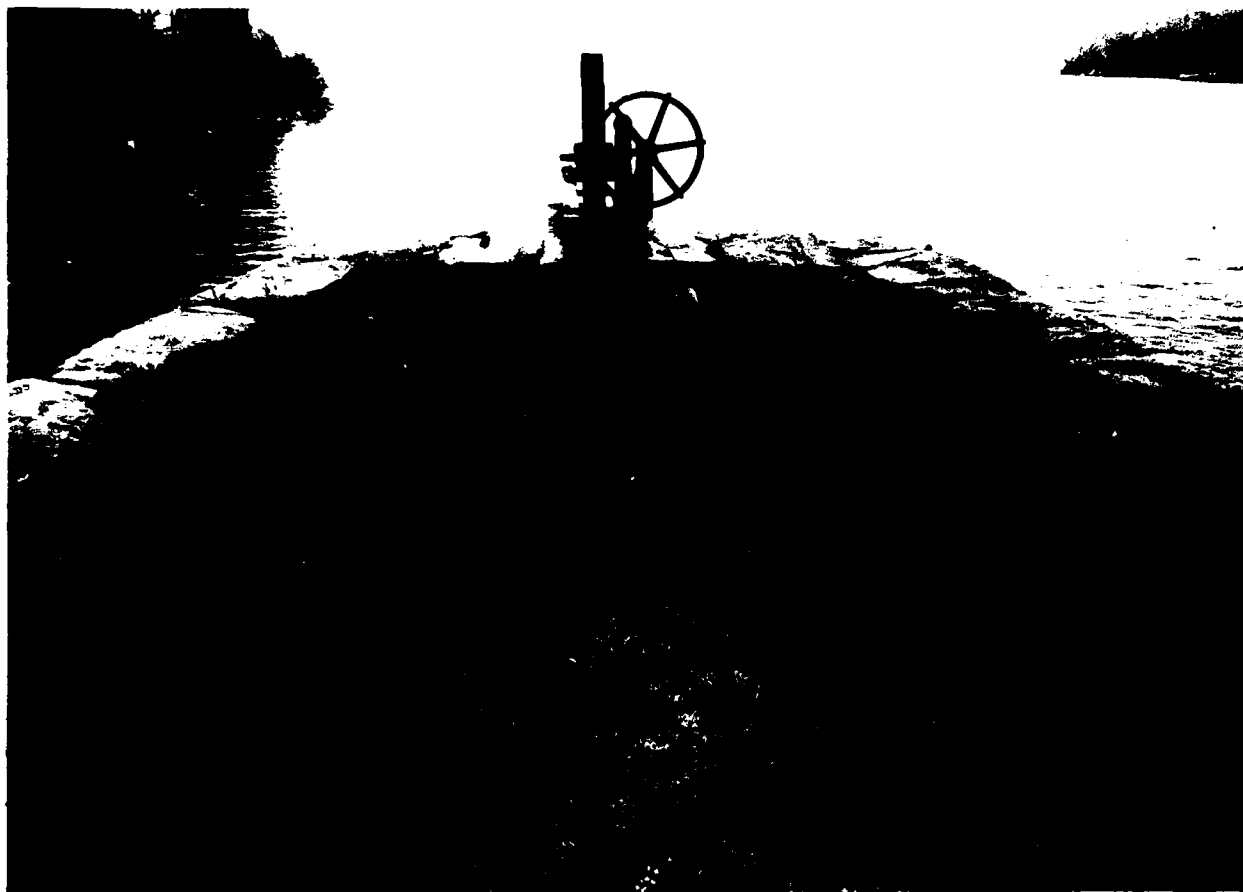
- c. Appurtenant Structures: Surface erosion holes up to 2.75 feet deep were found on the upstream end of the gate support structure. See Plate No. 3 for locations and Photograph No.C-11. Surface erosion holes were also found along the westerly spillway wall immediately west of the stonework. These are very likely due to loss of soil from openings between stones resulting from inadequate filter material between the stonework and the soil. The spillway was found to be seriously undermined and inadequate in size. Training

C-II SINKHOLES AT GATE MECHANISM
